# Manhole Inspection Summary

Manhole # S43K\_\_036MH

Insp Date: **6/4/08 9:10 AM**

**Location** Address: **1501 eastern ave**

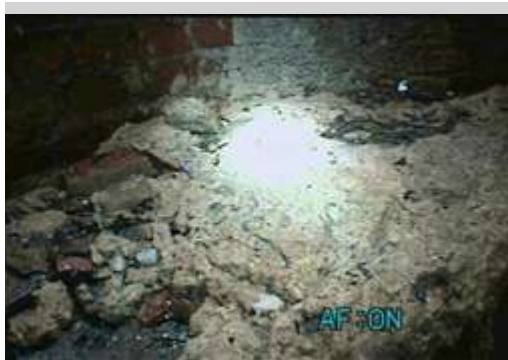
Defect 2

Condition: ☐ Sound ☐ Cracked ☐ Root Intrusion ☐ Deteriorated ☐ Leaks ☒ **Debris**

bench debris

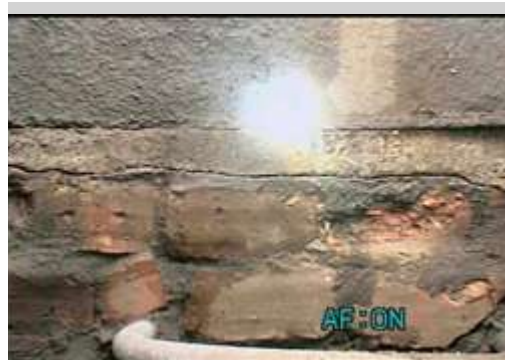
Defect 1

Condition: ☐ Sound ☒ **Cracked** ☐ Root Intrusion ☐ Loose Brick ☐ Deteriorated

chimney cond cracked

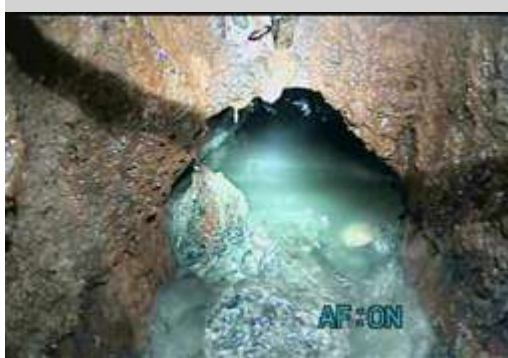
Defect 4

Condition: ☐ Sound ☐ Cracked ☐ Root Intrusion ☐ Deteriorated ☐ Leaks ☒ **Debris**

channel debris

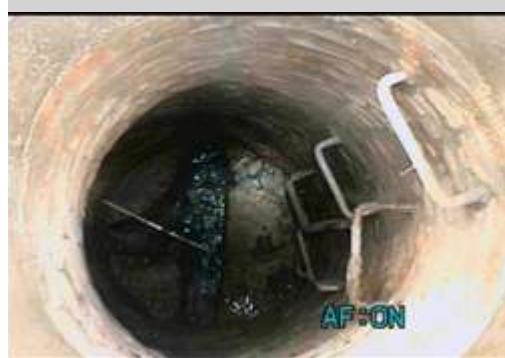
Defect 3

Count: **7** Missing: **1** ☒ **Corroded**

missing/corroded steps

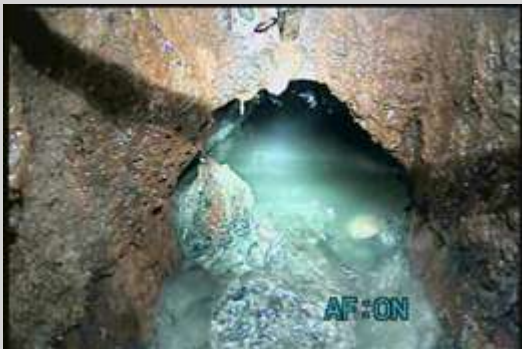
6 O'Clock Inflow

Deposits: ☐ None ☐ Mud ☐ Sludge ☒ **Debris** ☐ Grease

Silt Depth: 3 (in.) Deposits Extent: **Medium**
